No. 243

Date: 13.03.2012

MT5 platform updates

ON LINE UPDATE

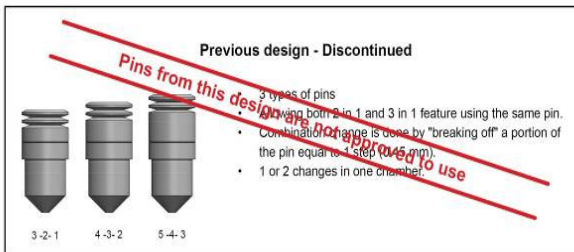
In the previous design of the variable pins, the combination change was done by "breaking off" a portion of the pin that is equal to 1 step (0.45 mm). In the improved design, we have modified the size of the "breakable" portion to 2 steps (0.90 mm). This modification improves the functionality and reliability of this feature.

Improved design

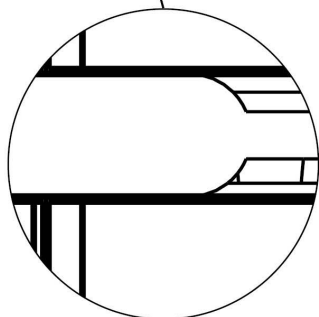
Difficult to take the key out

Alpha spring jammed in the intersection point of the drill and the keyway. Curved milling was added in the plug for free movement of the Alpha spring and removing the sharp edge between keyway and Alpha spring drill.
